City of Richland Hills, Texas

To: Honorable Mayor Bill Agan and members of the Richland Hills City Council  
From: Eric Strong, City Manager  
Date: September 20, 2016  
Subject: Traffic Study

Re: *Speed Study and Multiway Stop-Control Studies along Popplewell Street*

Lee Engineering has conducted a speed study and two multiway stop control studies along Popplewell Street within the City of Richland Hills. This letter report presents the results of our study.

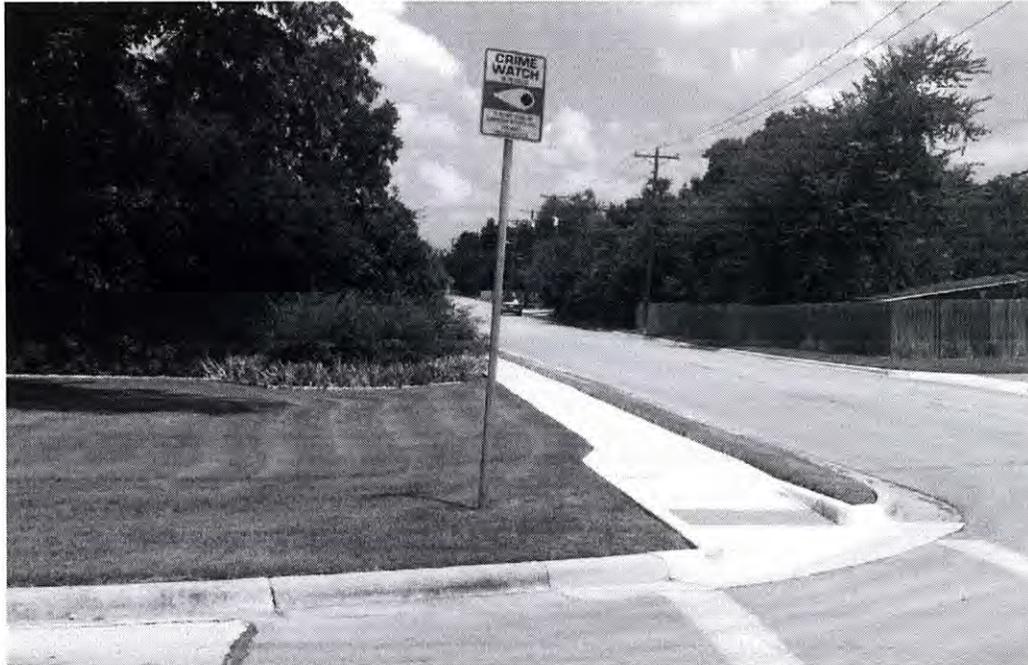
Comparison of the field investigation results of the available sight distance to the desired sight distance indicates that the available sight distance is not adequate for vehicles on the eastbound approach of Hovenkamp Avenue. The sight obstruction was posed by vegetation and fence on the property on the northwest corner of the intersection.

**Figure 1. Sight Distance Obstruction on Eastbound Hovenkamp**

The vegetation on the northwest corner of the intersection should be trimmed if possible to increase available sight distance.

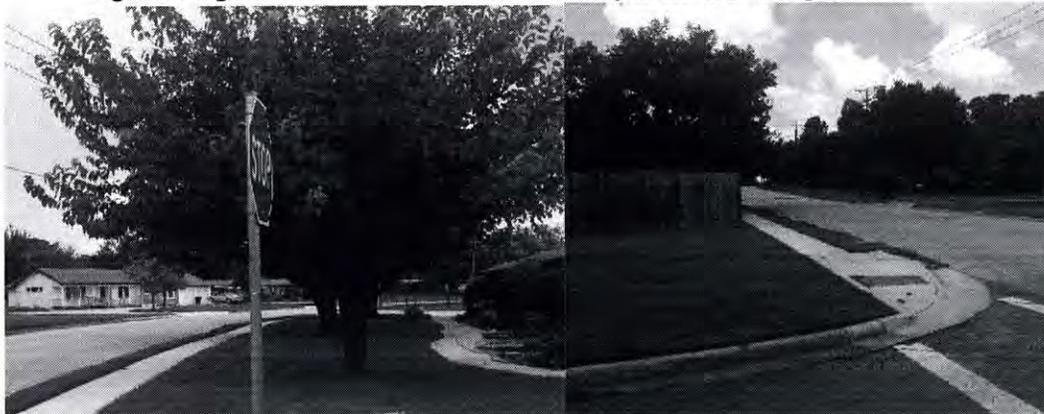
Comparison of the field measured available sight distance to the desired sight distance indicates that the available sight distance is not adequate for vehicles on the eastbound approach of Richlynn Terrace. The intersection sight distance was obstructed by a fence on the northwest corner of the intersection and the large trees on the southeast corner.

**Figure 2. Sight Distance Obstruction on WB Richlynn Terrace: To Right and To Left**

1. The speed limit on Popplewell Street between SH 26 and US 183 should remain at the existing 30 mph limit. A higher speed limit should not be installed at this time due to the number of intersections along the corridor and the multiple intersection sight distance obstructions along the corridor.
2. Multiway stop-sign should not be installed at either of the two locations studied at this time. Crash data should be monitored to determine if any changes are necessary in the future.
3. Due to the minor intersection sight distance obstructions, installation of intersection warning sign assembly (W2-1) along northbound and southbound Popplewell Street upstream of the intersection of Popplewell Street and Rychlynn Terrace is recommended.
